# TEST REPORT

**Specimen : Notebook computer**

**Model/Spec. : Casper Nirvana X100/X200**

**Report No. : 26080306C01-R1**

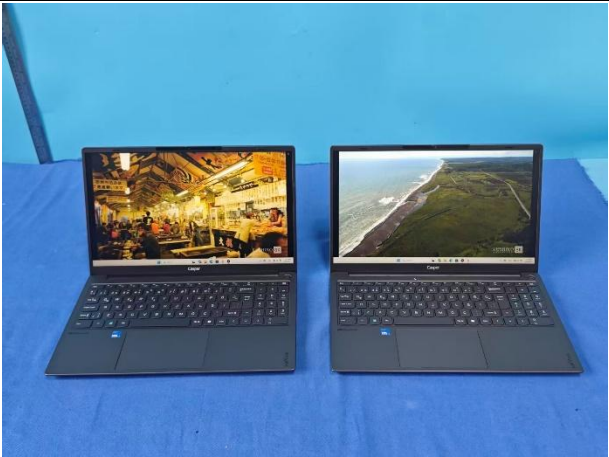
| No.4-1 Inspection before test | No.4-2 High temperature test (operation)<br>specimen placement |

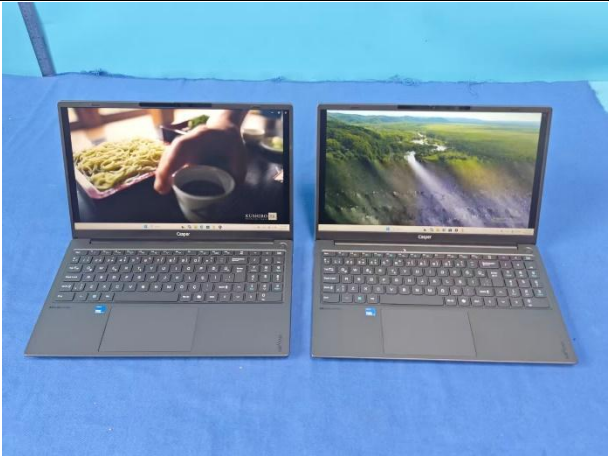
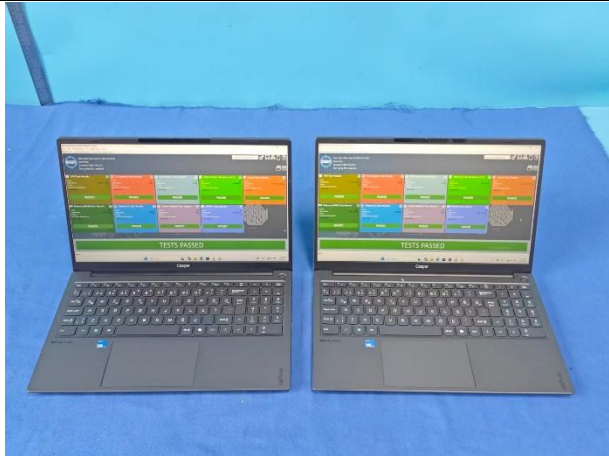
- 1) During the test, the specimens exhibited no functional failure.
- 2) After the test, the specimens exhibited no appearance damage or functional failure.

| No.4-3 Inspection after test | No.4-4 Inspection after test |

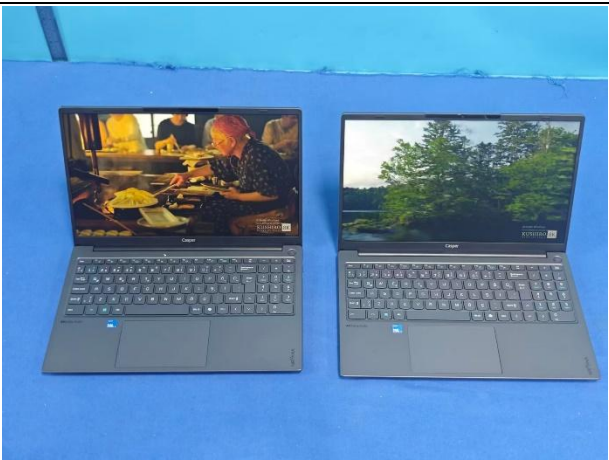
| No.5-1 Inspection before test | No.5-2 Low temperature test (operation)<br>specimen placement |

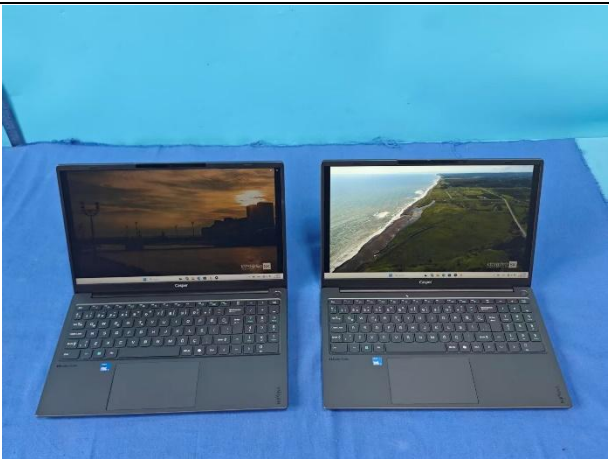
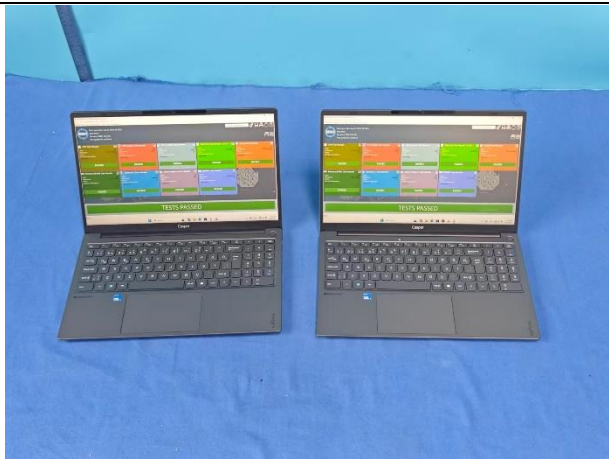
- 1) During the test, the specimens exhibited no functional failure.
- 2) After the test, the specimens exhibited no appearance damage or functional failure.

| No.5-3 Inspection after test | No.5-4 Inspection after test |

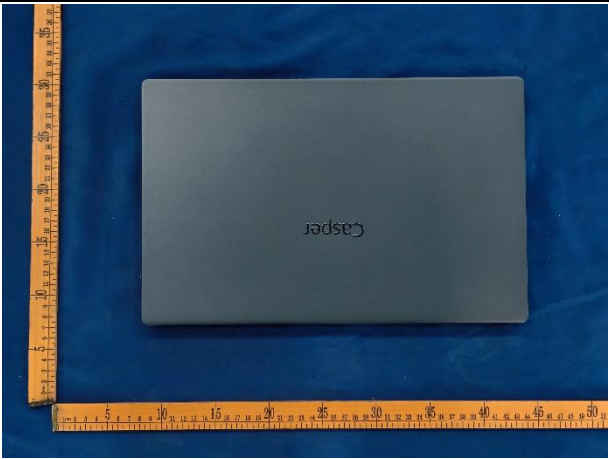
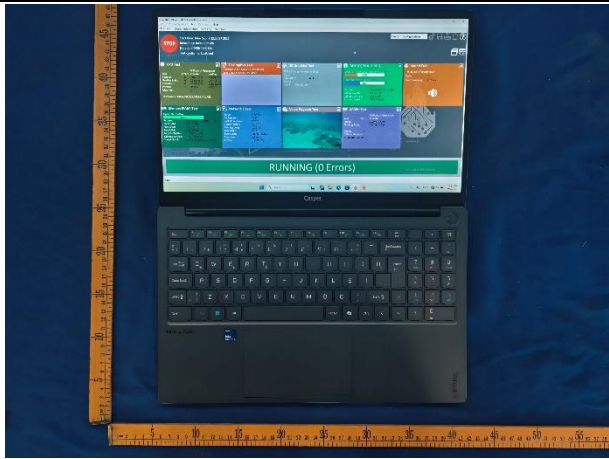
| No.6-3 Inspection before test<br>(ACSH202609009-S02 specimen) | No.6-4 Inspection before test<br>(ACSH202609009-S02 specimen) |

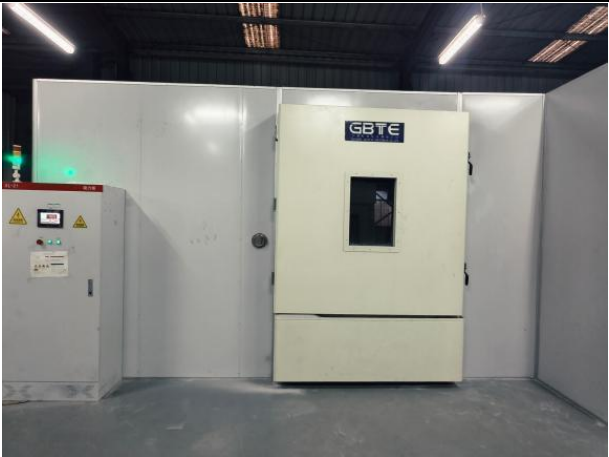
No.6-7 Specimen Position (In test)

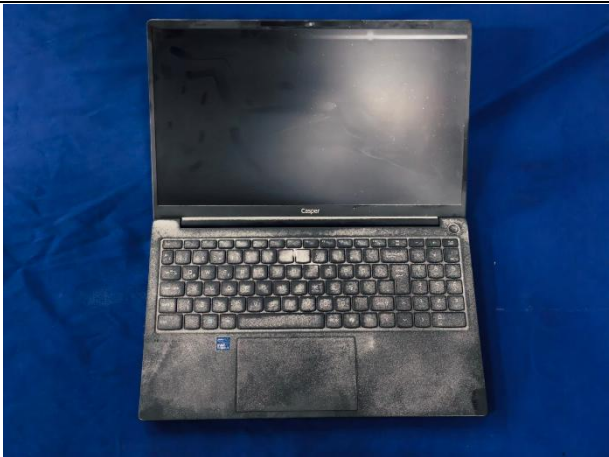
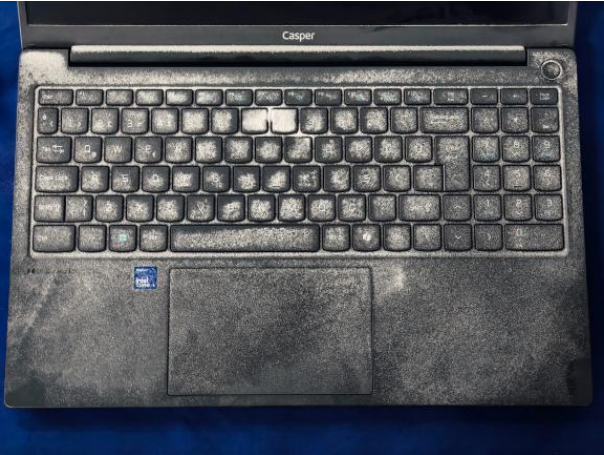
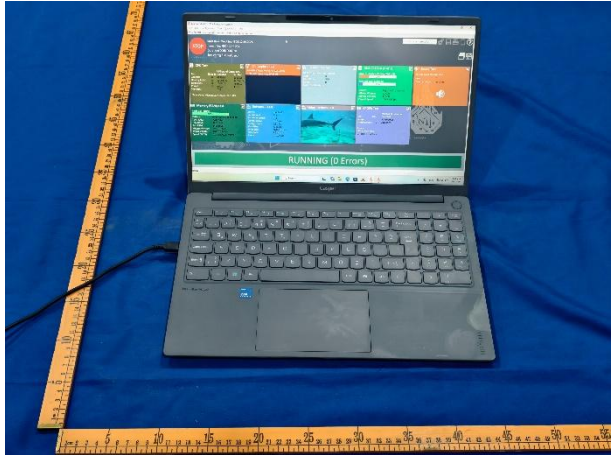
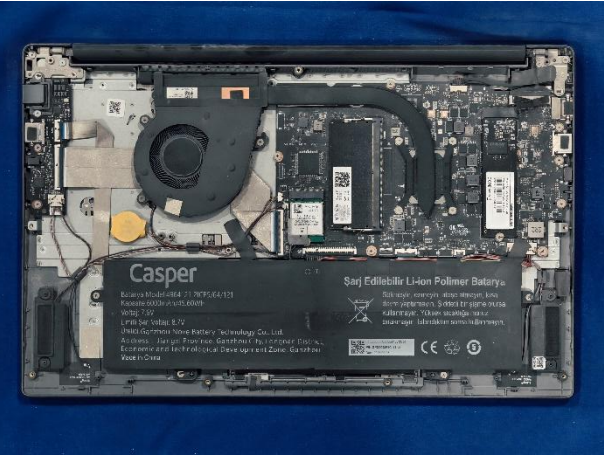
- 1) After the test, the specimens exhibited no appearance or structure damage: the sand dust did not cause adhesion, blockage, jamming of moving parts or obstruction.
- 2) After the test, the specimens exhibited no functional failure: they could be powered on normally, the screen displayed correctly and the 30-minute burn-in test did not generate any errors; the speaker produced no abnormal noise or distortion.

No.6-12 Inspection after test  
(ACSH202609009-S01 specimen)

| No.6-13 Inspection after test<br>(ACSH202609009-S01 specimen) | No.6-14 Inspection after test<br>(ACSH202609009-S01 specimen) |
| No.6-15 Inspection after test<br>(ACSH202609009-S01 specimen) | No.6-16 Inspection after test<br>(ACSH202609009-S01 specimen) |
| No.6-17 Inspection after test<br>(ACSH202609009-S01 specimen) | No.6-18 Inspection after test<br>(ACSH202609009-S02 specimen) |

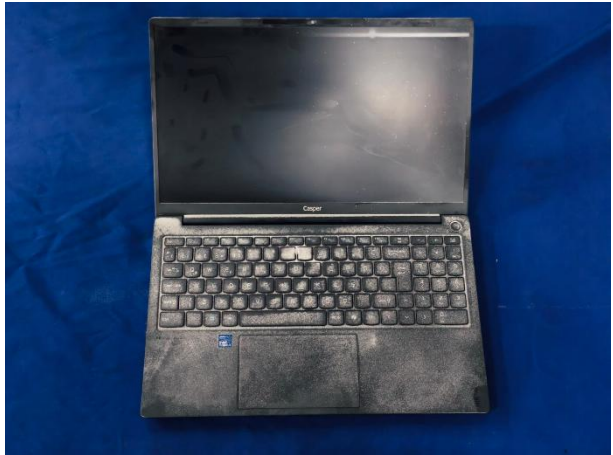
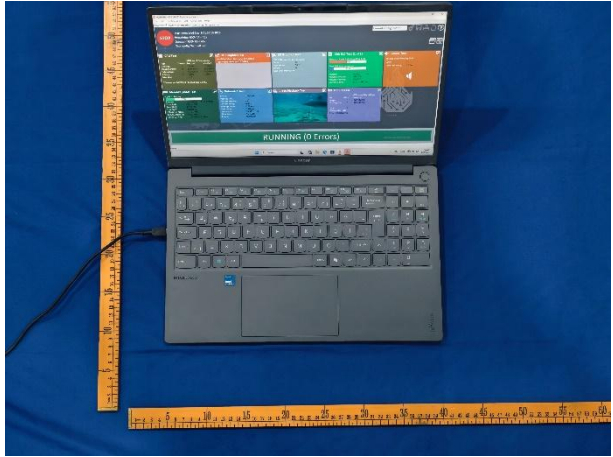
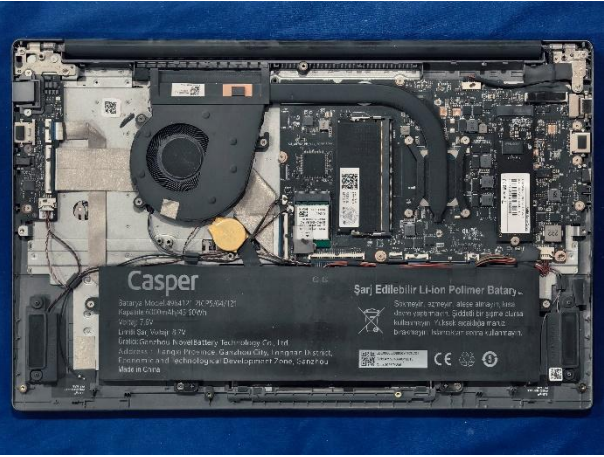
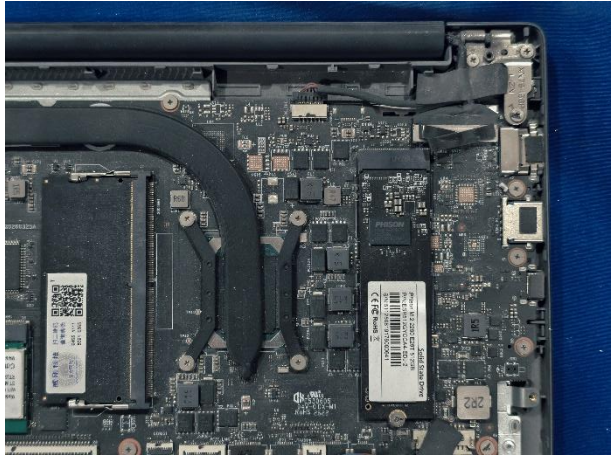
| No.6-19 Inspection after test<br>(ACSH202609009-S02 specimen) | No.6-20 Inspection after test<br>(ACSH202609009-S02 specimen) |
| No.6-21 Inspection after test<br>(ACSH202609009-S02 specimen) | No.6-22 Inspection after test<br>(ACSH202609009-S02 specimen) |
